Effective Use of Irrigation Water in Case of Interfirm Canal

Annotation. This article deals with the problems of large water losses in the “Ak-Yab” canal (Khorezm province, Uzbekistan) for filtration, as well as the factors that prevent this circumstance. At a time when the value of each drop of water is high and there is a shortage of water, the efficient use of irrigation canals to supply the water needed for crops is relevant. As a matter of this study, the assessment of the current state of the canal and the technical condition of the hydraulic structures in it was carried out using the observation methodology and long-term analysis of the collected data on this canal (in-situ). From a scientific point of view, specific proposals and conclusions were given for the repair and construction of the canal and its hydraulic structures. From a practical point of view, on the basis of data on the study of the state of the canal in the field, together with specialists in this field, the priorities for repair, rehabilitation and construction have been determined along the length of the Ak-Yab canal.

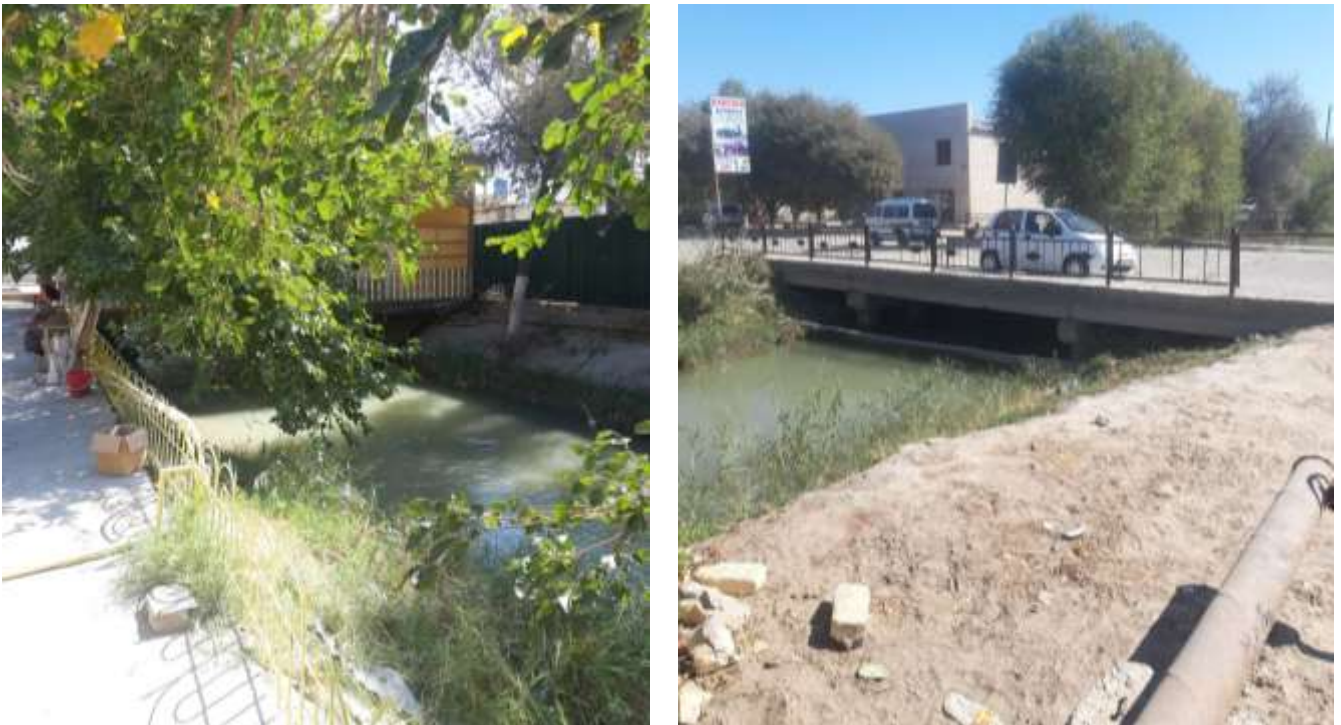
Figure 3. Overall view of the Ak-Yab canal

The reconstructed part of the Ak-Yab canal will supply water to 3,975 hectares of land on the territory of the Kenik-Polvon and Boz-Yab Water Consumers Associations (WCA) (Figure 3). The orientation of these WCAs by crop type is based on cotton. The normal water flow capacity of the canal is 5.0 m³/sec, and the length of the canal is 3,431 km, of which 2,047 km are soil-founded (PK88 + 55 to PK102 + 60 and PK116 + 44 to PK 122 + 86), and 1,384 km (PK102 + 60 to PK 116+). 44) with concrete coating. According to the research output, it is necessary to reconstruct the part of the canal from PK89 + 55 to PK122 + 86.

The canal was the main source of riverbed modification. Based on the results of the monitoring, it was required to carry out mud removal works in the part of the canal from PK 89 + 00 to PK173 + 00.

The hydraulic structures in the canal are outdated and in need of maintenance. The metal equipment of the barrier structure at PK 91 + 44 was unusable and unsafe; the concrete parts were broken. The metal bridge of the hydrounit at PK 92 + 58 was unusable, and the core was not covered with concrete. Moreover, it was observed that there was no water-measuring point. Pedestrian bridges at PK 99 + 52, PK 100 + 40, PK 117 + 40 were built on the basis of craftsmanship, dangerous for the passage of the population.
