Technical Condition of Korakol Pumping Station

Abstract: This article describes the technical condition of the Karakol pumping station in the Bukhara region during its operation.

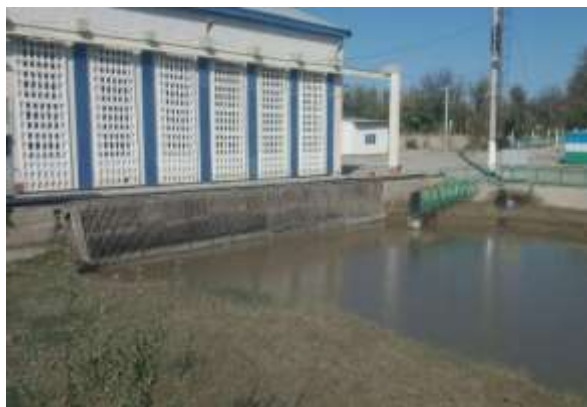
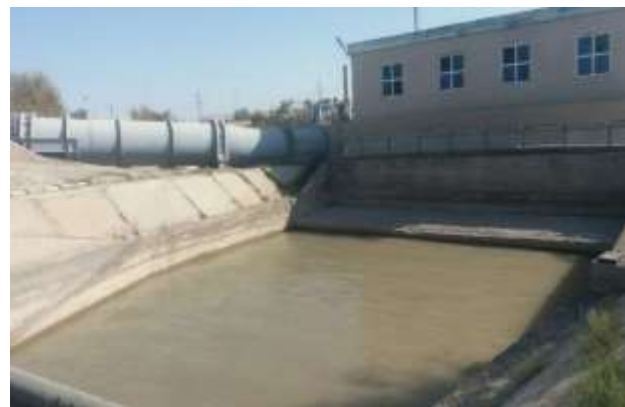
Pic-1. Pumping station

Avankamera - cloudy, suspended sediments occupy the surface of the water in front of the fence.

The pump unit - the working wheel is damaged, the impellers have finished their work, cavitation is occurring as a result of air mixing with water.

Pressure Pipe – Due to the high turbidity of the water in the delivery channel, the pressure pipe has been eroded.

Conveying channel - the slopes of the channel have been reeded, silted, and the slope coefficients have changed as a result of reeding.

- Recommendations for improving the operation of the pumping station
- - It is necessary to clean the leading channel from turbidity;
- - It is necessary to clean the reeds on the canal slopes;
- - It is necessary to regularly clean the mud in the front camera;
- - It is necessary to carry out current repairs of pumping units on time;
- - It is necessary to check the pressure pipes and repair or replace the corroded areas;
- - It is necessary to install a hydopost in the carrying channel. The reason is to measure the water consumption from the pumping station;
- - It is necessary to restore the slopes of the carrying channel based on the project;
- - It is necessary to constantly improve the qualifications of the working staff;
- - It is necessary to use foreign experiences in the processes of use.
